UNDERWATER BRIDGE INSPECTION REPORT

STRUCTURE NO. 69623

ST. LOUIS RIVER

MINNESOTA DEPARTMENT OF TRANSPORTATION
UNDERWATER BRIDGE INSPECTION

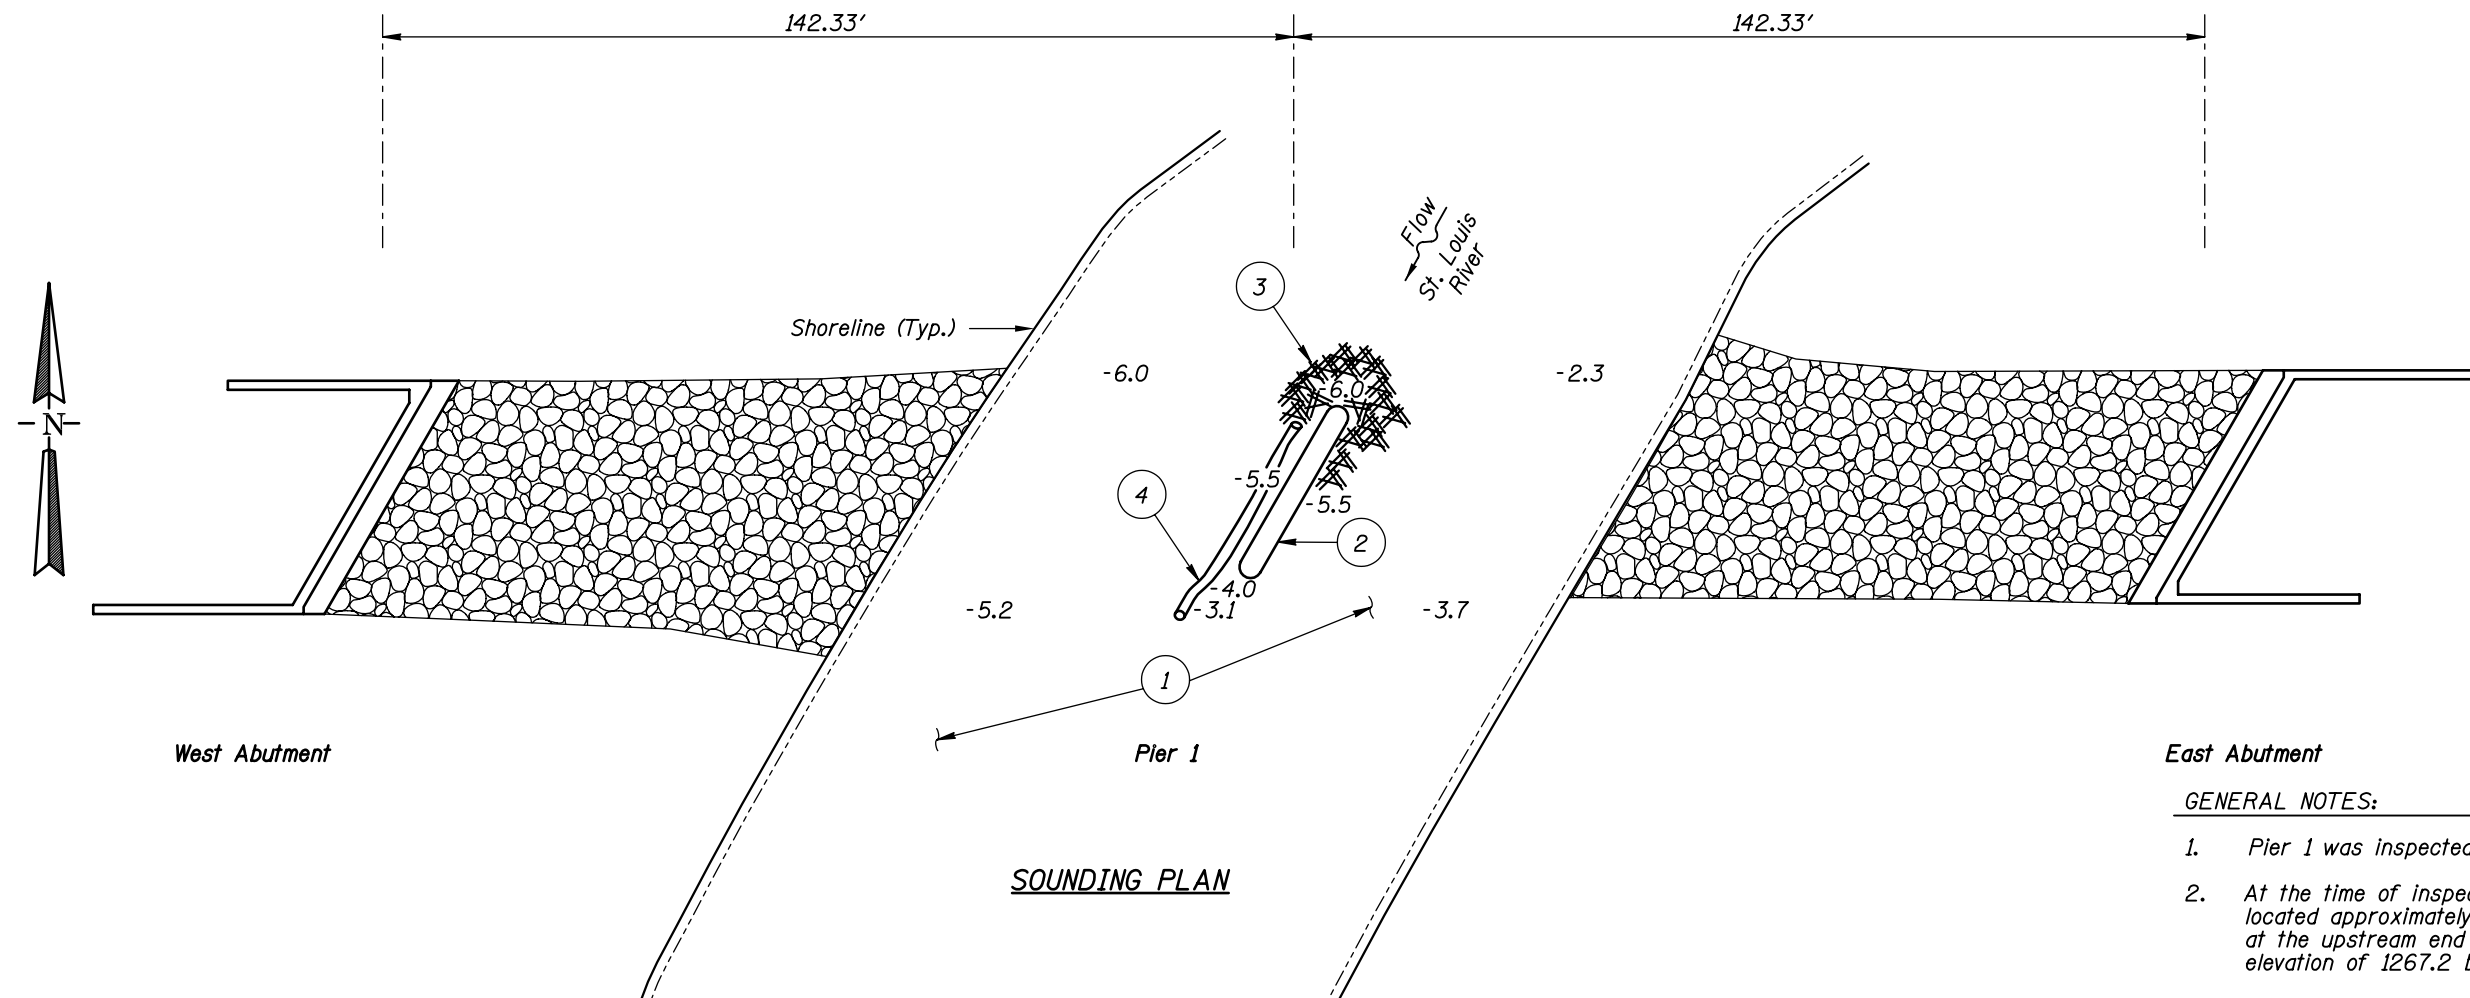
INSPECTION AND SOUNDING PLAN

1. The channel bottom consisted of soft silt with 1.5 to 2 feet of probe rod penetration and riprap at the upstream nose of Pier 1.
2. The concrete of Pier 1 was in good and sound condition.
3. A heavy accumulation of timber debris was observed at the upstream nose of Pier 1 extending from the channel bottom to 6 feet above the waterline. The accumulation extended approximately 20 feet into the channel and from about 20 feet upstream of the nose to halfway down the east side of the pier, with a 2-foot-diameter log extending along the west side of the pier.
4. A 2-foot-diameter log was observed along the west side of Pier 1.

- (A) Remove the heavy accumulation of timber debris at the upstream nose and along the side of Pier 1 to alleviate scour influence at the pier and any further accumulation.

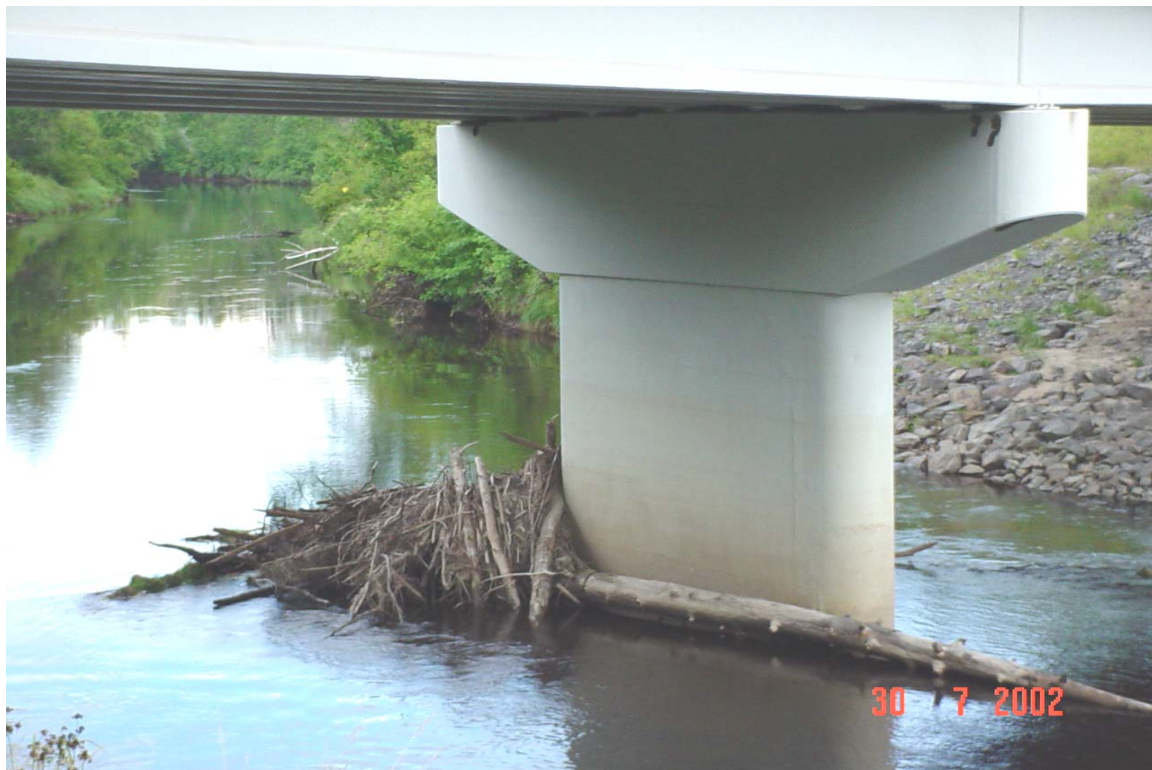
- (A) The concrete of Pier 1 was in very good condition with no notable deterioration.
- (B) A heavy accumulation of timber debris was observed at the upstream nose of Pier 1. The accumulation extended approximately 20 feet into the channel and from about 20 feet upstream of the nose to halfway down the east side of the pier, with a 2-foot -diameter log extending along the west side of the pier.

Photograph 2. View of Pier 1 and Heavy Drift Accumulation, Looking Northeast.
